EVALUATION OF M9M1 LANDING MAT

Army Engineer Waterways Experiment Station  
Vicksburg, Mississippi

July 1963

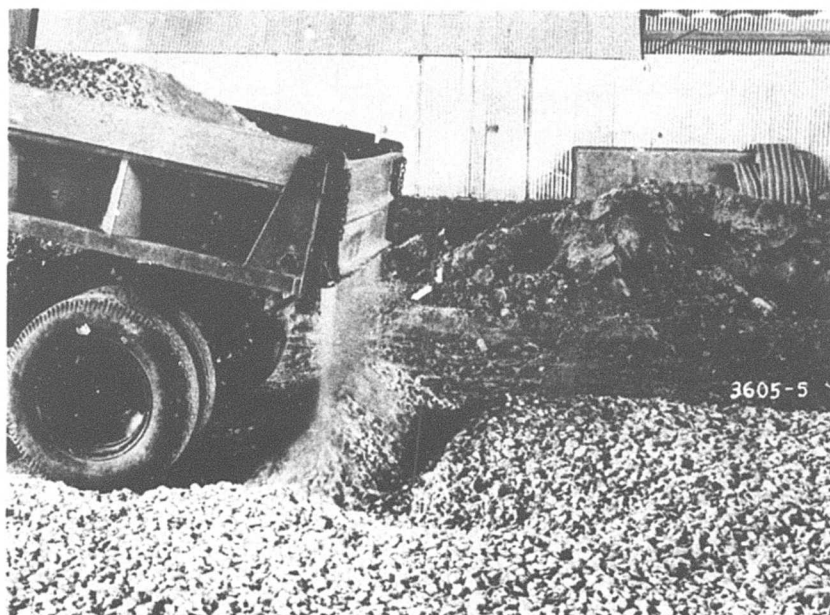
Fig. 2. End-dumping  
rock in item 3

9. Items 3 and 4. Item 3 consisted of 12 in. of uncompacted, loose rock that was end-dumped (fig. 2) and spread by hand. Due to the coarseness of the material and the loose state in which it was placed, no attempt

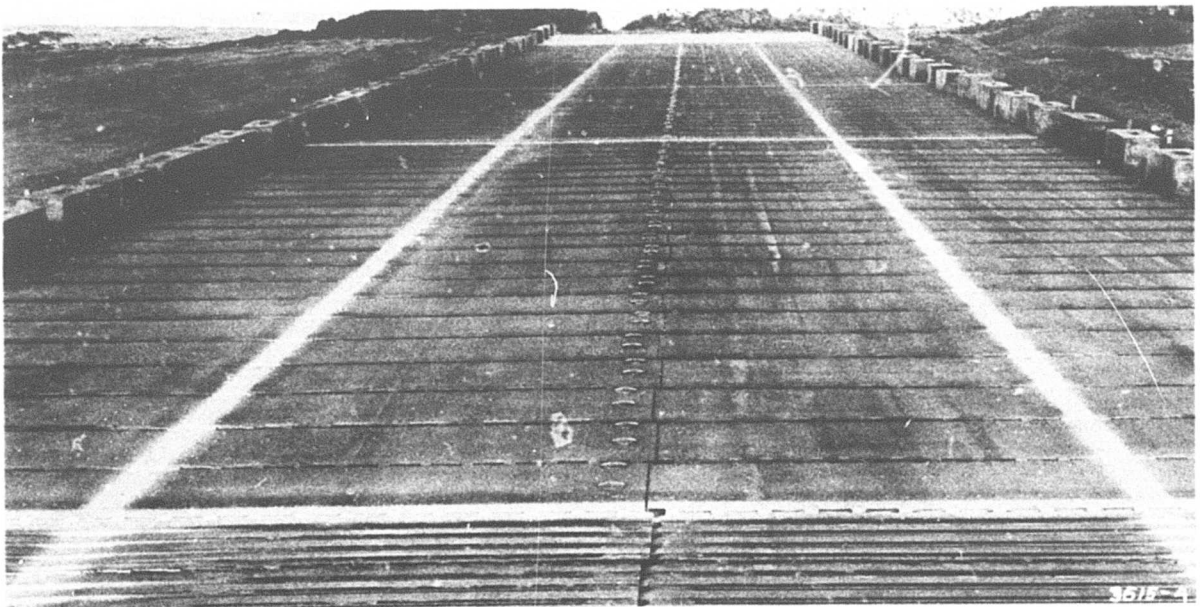
Fig. 4. Test section after placement of mat with end-joints in a straight line. (Mat in approach section in foreground is T10 aluminum)

19. As mentioned earlier, the mat was originally placed with all end joints in a straight line down the center line of the test section (see fig. 4, page 6). As traffic was applied, the M9M1 mat deformed severely. After two coverages, the end joints down the center of the traffic lane had curled up and arched, forming a ridge 2 to 3 in. high for the full length of the traffic lane. Photograph 1 shows a close-up of this condition in item 1. After six coverages, the ridge down the center line was more pronounced (see plate 4). The planks had arched about 3 in. above the subgrade and were not deflecting down to the subgrade under the wheel load. A general view of the test section after six coverages is shown in photograph 2. A large number of rivets near the end joint and welds on the bayonet edge had broken by this time. Therefore, traffic was discontinued and the NAEL was informed of the mat's performance. Representatives of NAEL and the Marine Corps Equipment Board then visited the WES to observe the condition of the landing mat. It was agreed that the mat was unsuitable for the design aircraft traffic when laid with the end joints in a straight line, and that the mat should be tested with the joints staggered.

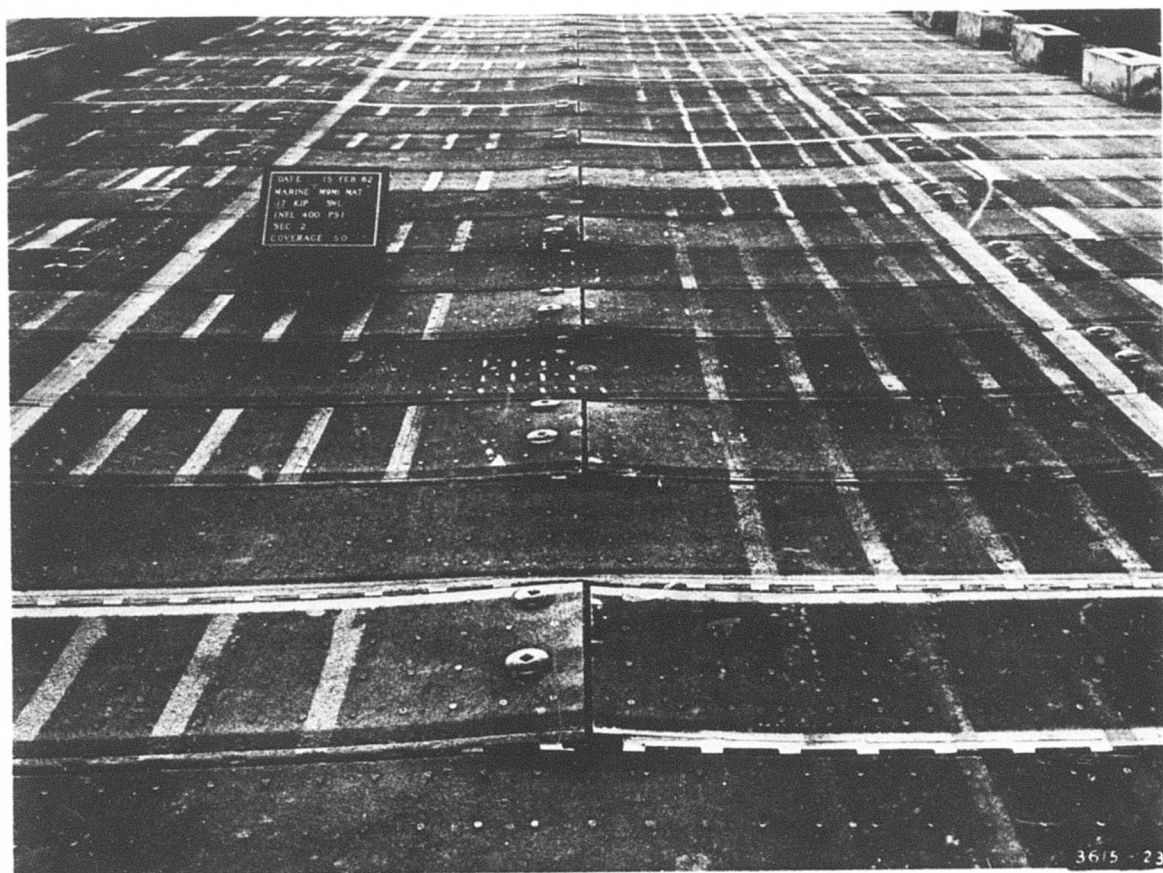
Photograph 6. Item 2 after 50 coverages

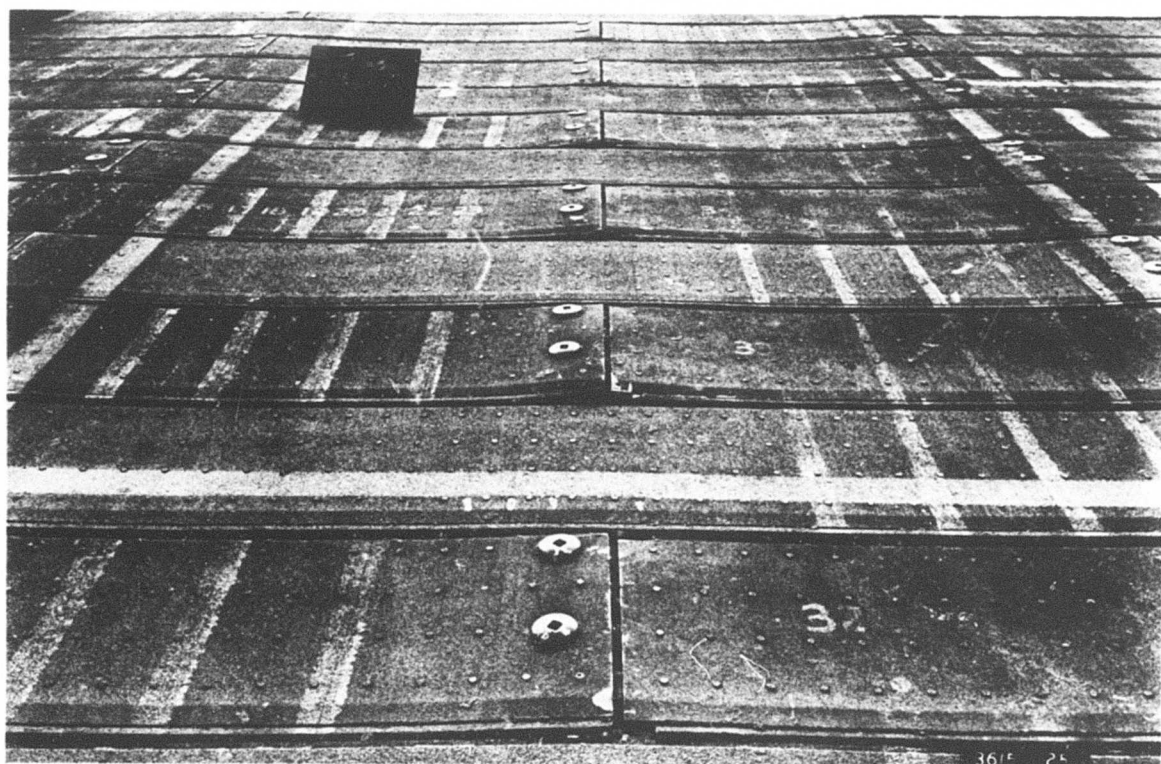
Photograph 8. Item 4 after 50 coverages
